# **San Francisco Fire Department**

### **Training Bulletin 22-5**

## **New Low-Pressure Hydrant Marking Standard**

**April 2022**

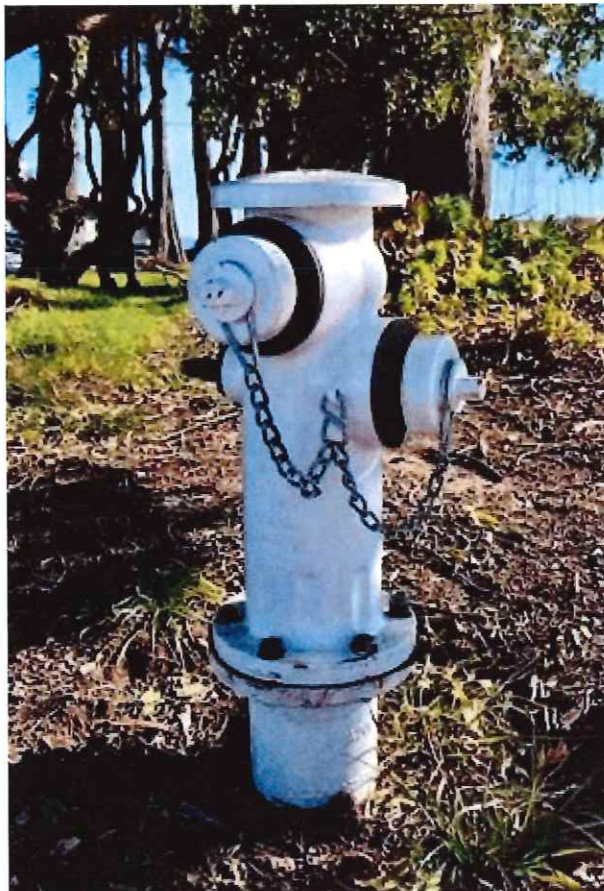
The hydrant pictured below is a new Mueller hydrant. Note the bronze outlet faceplates are the same color and shape as the black "out of service" discs that are currently being used.

The new marking standard for the Mueller Company hydrants is to stamp the information on the bronze face of the upper outlet. However, in a certain light, the bronze faces of the outlets can look like black out-of-service discs. This optical peculiarity could cause an engine company to pass by a functional hydrant in search of a supply.

To avoid confusion, the Water Department has begun the process of painting the out-of-service discs to **RED**. Effectively immediately **RED** discs will be used to designate a hydrant as being out of service.
